# PRODUCT ADVISORY NOTICE

**Subject:** Change to 3<sup>rd</sup> Generation CAN transceiver

Grayhill will be changing products currently using NXP Semiconductor CAN transceiver TJA1050T/VM,118 to the next generation NXP Semiconductor CAN transceiver TJA1051T/CM,118.

| Test Report Number: | VU19-93 |

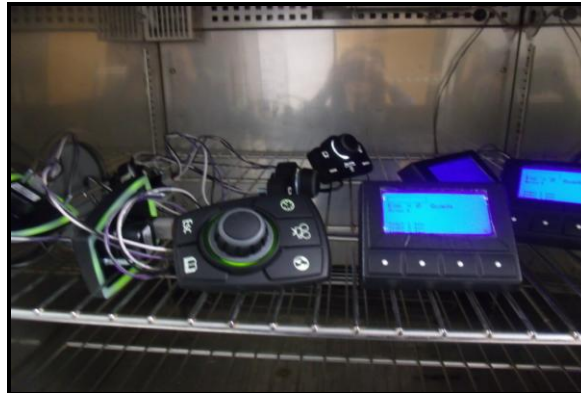
Figure 2–Test setup

1. Visual Inspection of the DUT is to be performed before testing.
2. Perform functional test.
3. Place the DUT inside the chamber.
4. Power up the chamber at the specified temperature.
5. Apply voltage to DUT (shown in Table 5 Test conditions)
6. Continue to cycle the DUT according to the test condition table.
7. Perform Visual inspection of the DUT after completing thermal profile

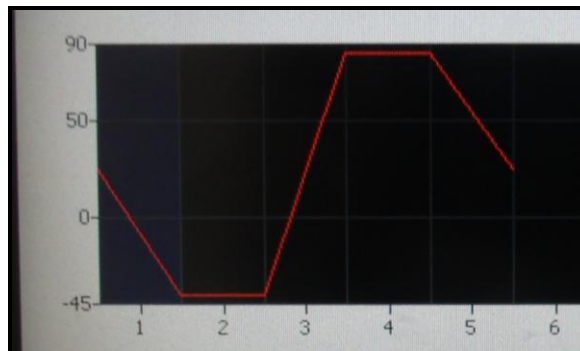
Figure 3 – Temperature profile (one complete cycle)

| Test Condition | Units | Parameters |
|---|---|---|
| Minimum Test Temperature | °C | -40 |
| Maximum Test Temperature | °C | 85 |
| Dwell Time | Hours | 2 |
| Temperature change rate | °C/min | 1 |

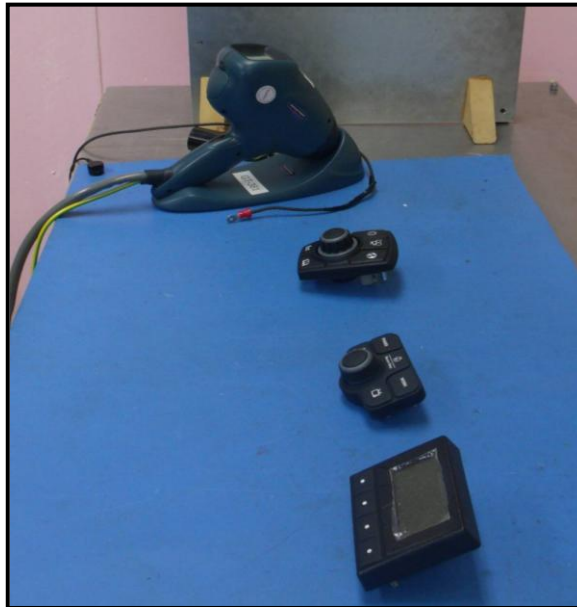
Figure 4-Test Setup

1. Visual check.
2. Mount the DUT in the Mounting Orientation specified in the Test Conditions if applicable.
3. Load the discharge network specified in the Test Conditions.
4. Apply the pulse to the DUT in the sequence specified in the Test Conditions.
5. Perform functional check after each voltage level
6. Perform the Visual Check after exposure.

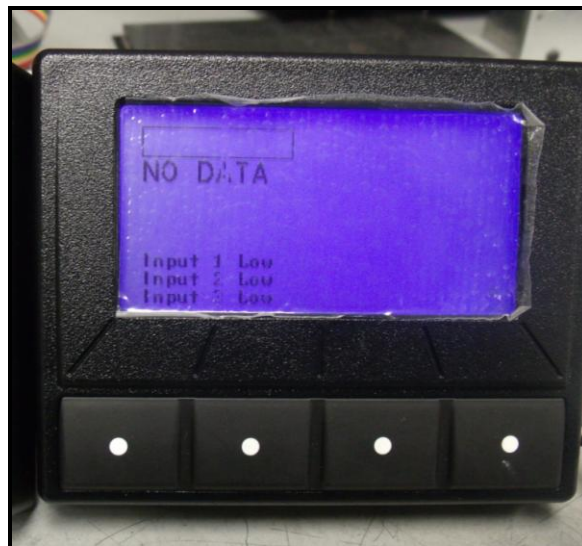
The Nexgen CAN transceiver operated as intended. After unpowered ESD testing, all (3) micro display units showed some pixels that were missing from the display (shown in figure 5), all units still functioned as intended. After being analyzed by engineering, it was requested that an older version of a micro display be tested. After retest of the older version, it was found that it too had the same results as the original micro display. A retest was done on two additional micro displays. Both passed the minimum requirements of 8kV for unpowered ESD, however for contact discharge the maximum voltage tested was 15kV and for ESD testing, contact discharge is not considered passing at 15kV. Both units on retest passed and functioned as intended.

**\*Note all micro Display showed missing pixel on display\***

**Figure 5—Micro Display after unpowered ±25K**

**\* Note after completing unpowered testing DUT display was missing pixel same results as previous testing of the micro displays\***

**\*NOTE - at +15kV a vertical line appeared on the display screen on DUT 3DYY32C - 200, unit still function as intended. ESD testing for contact discharge is not considered passing at 15kV, but all DUT met the 8kV requirement for unpowered ESD testing.\***

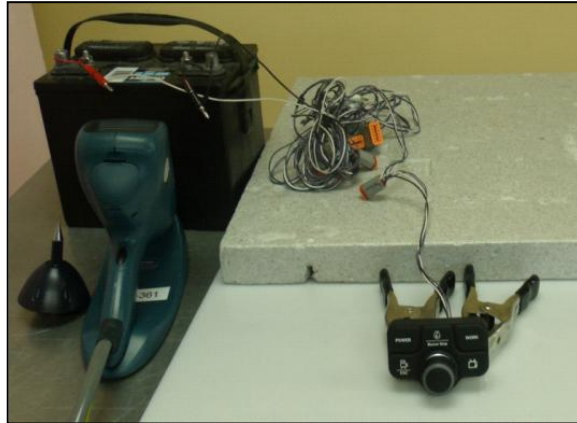
Figure 6– Test Setup of 3J1015-100

1. Visual check.
2. Mount the DUT in the Mounting Orientation specified in the Test Conditions if applicable.
3. Load the discharge network specified in the Test Conditions.
4. Apply the pulse to the DUT in the sequence specified in the Test Conditions.
5. Apply voltage specified in test condition table
6. Perform functional check after each voltage level
7. Perform the Visual Check after exposure.

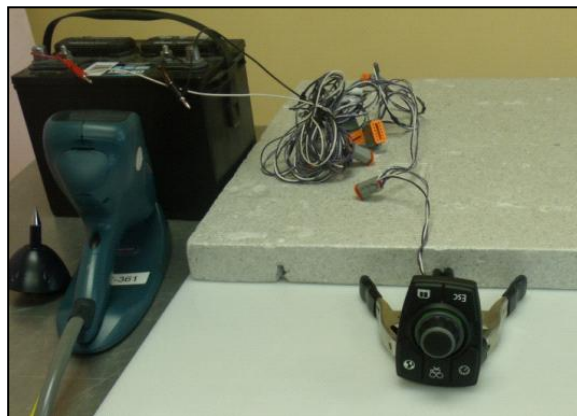
Figure 7– Test Setup of 3DYY32C-180

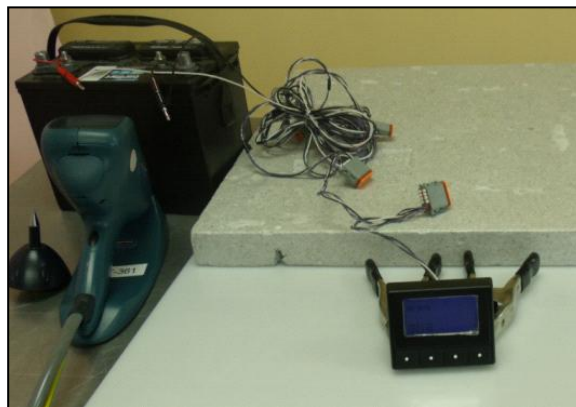
Figure 8– Test Setup of 3JYY1004-1
